THAMES RIVER BASIN  
STAFFORD, CONNECTICUT

RIVERSIDE POND DAM  
CT. 00336

PHASE 1 INSPECTION REPORT  
NATIONAL DAM INSPECTION PROGRAM

OCTOBER, 1980

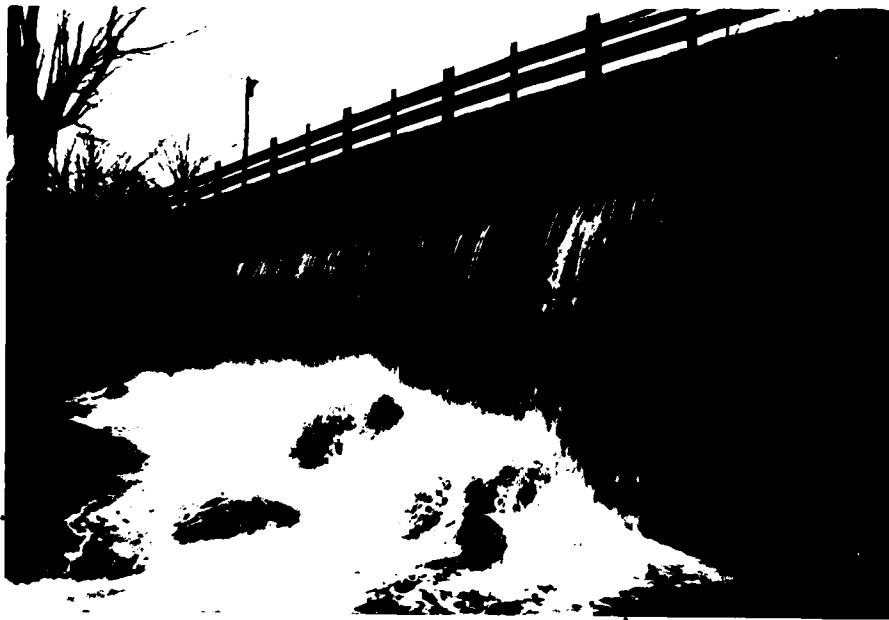
Extensive erosion caused by uncontrolled runoff from the roadway was observed on the upstream slope of the left abutment.
  3. Downstream Face. The downstream face of the dam consists of a stone masonry wall parallel with the spillway crest left of the spillway and perpendicular to the spillway right of the spillway crest. (See photos C-3 and C-4).

PHOTO C-3 Crest and downstream face of dam from left abutment.

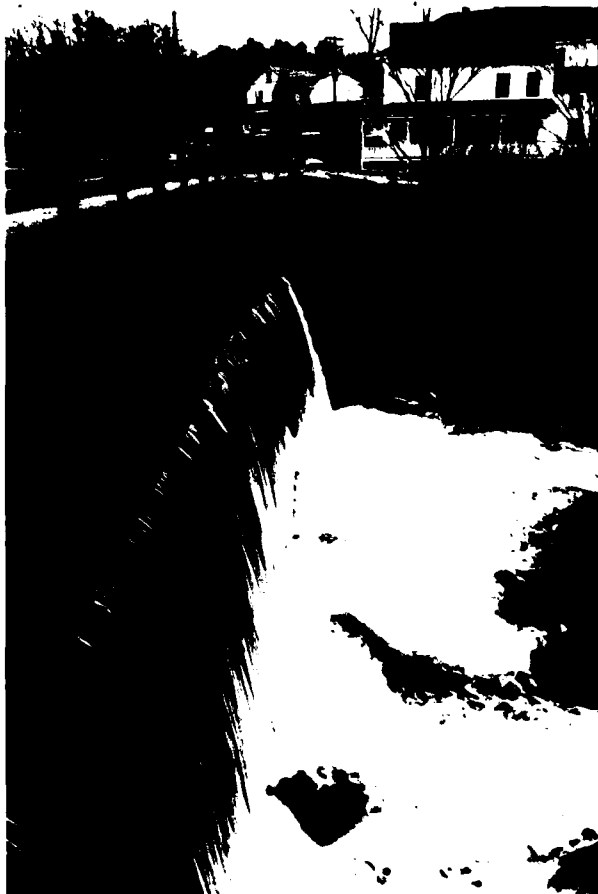
PHOTO C-4 Crest and downstream face from right abutment.
